EXHIBIT D

Re: DUBLIN: VSA Tunning

Here is an update on the activities at Valmiera VSA at Dublin, Ga.

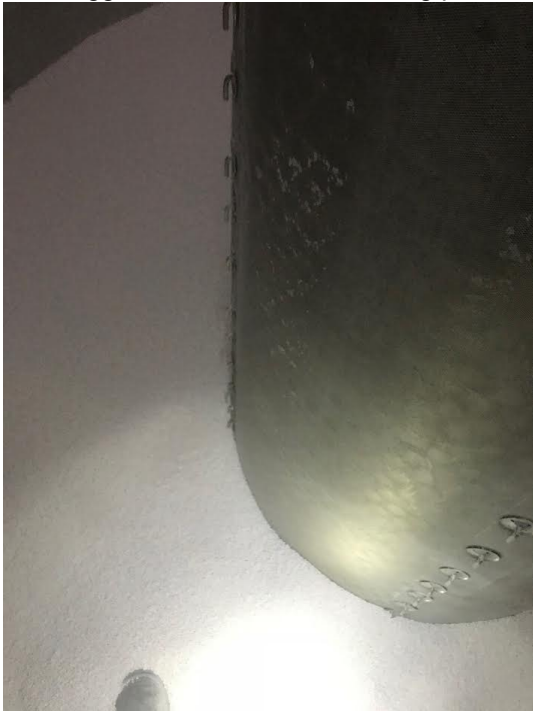
- **too high amount of alumina installed** -> I checked with our contractor on this. They mentioned the height of the Alumina installed is upto the bottom of the mol sieve column or where the internal Oxygen side grid starts inside the vessel. See below photos of the Alumina level from inside the vessel. This level seems to be little (4-5") higher than the level suggested in the standard filling procedure.

High settelling of AA due to filling process -> The level of the Mol sieve was checked while taking the Mol sieve samples out. The Mol sieve levels are same as filled originally. Also there was no gap observed between the membrane and top of the mol sieve.

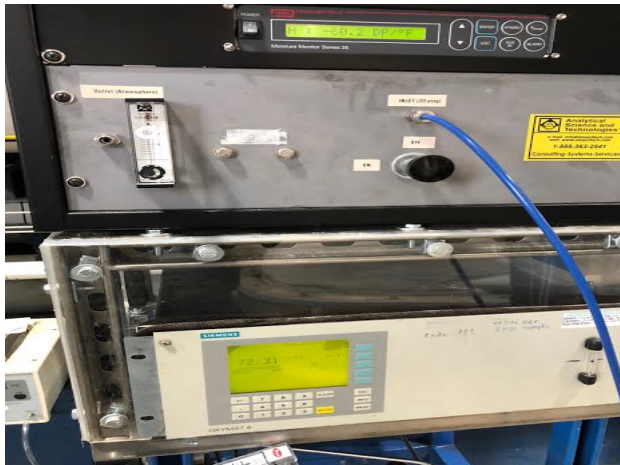
GOX dew point: The GOX dew point was measured using the Parametric Moisture monitor 35 yesterday. The Moisture monitor was showing the dew point at -60F. The dew point was falling down further but I had to shut the plant down late in the evening.

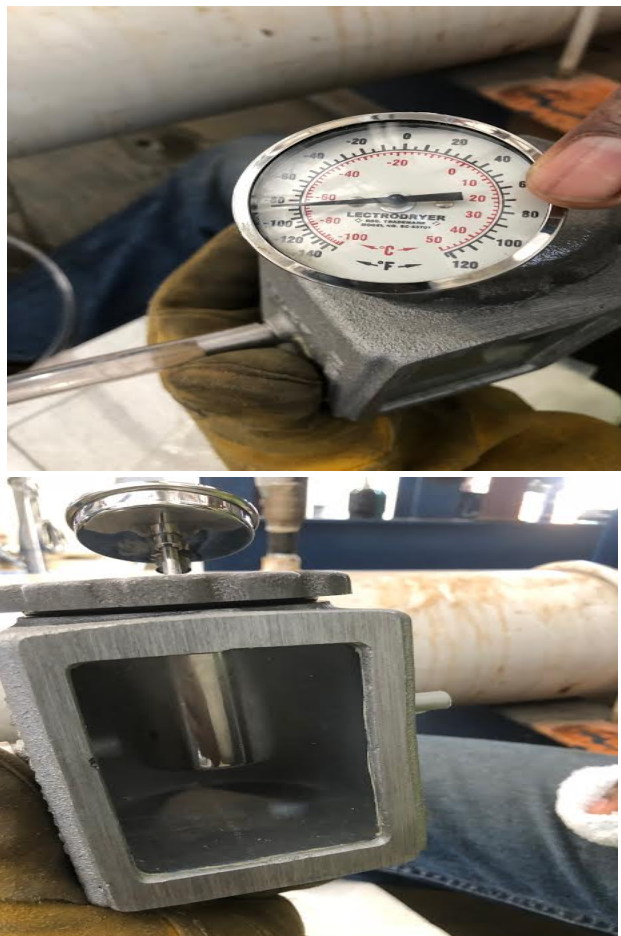
Also I would like to mention I had a dew cup onsite last week to measure the dew point of the GOX out of the VSA. The dew point of the GOX from the VSA is less than -90F. It was a simple dew cup I was able to find last week and I am waiting for another moisture analyzer to verify the readings .

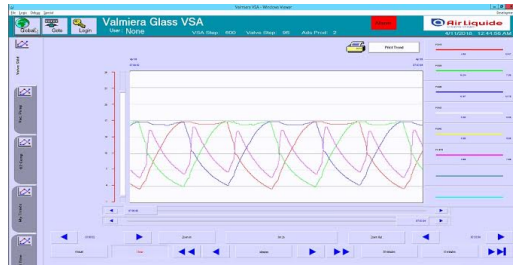
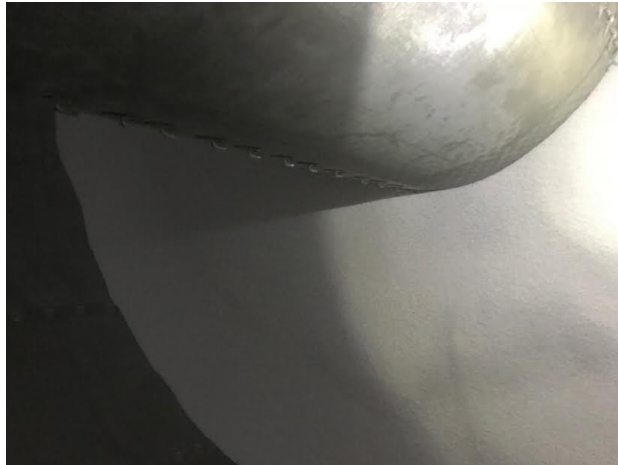
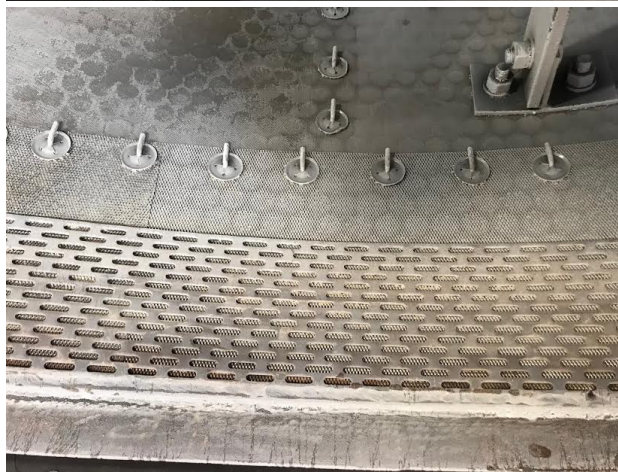
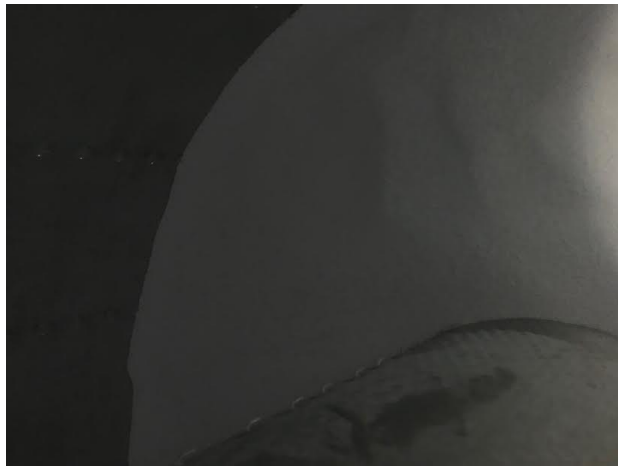
I did not see any big level trouble with these pictures.

I am also attaching some photos during the filling of the adsorber columns. If I find more photos I will send them to you.

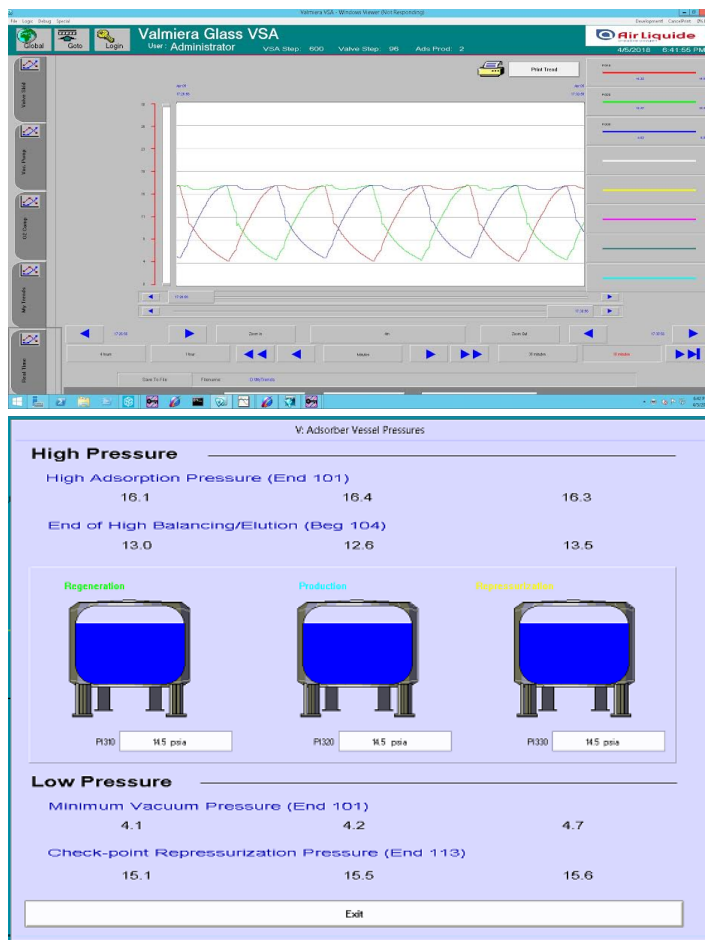
We ran the VSA yesterday with the changed cycle times as shown in the last column of the below photo,

The highlighted are the steps times we changed to for the VSA run.

We are having issue with the purity of the Oxygen product. The purity do not seem to go higher than the 71 - 72% of Oxygen in the product stream. I am also checking the analyzer calibration.

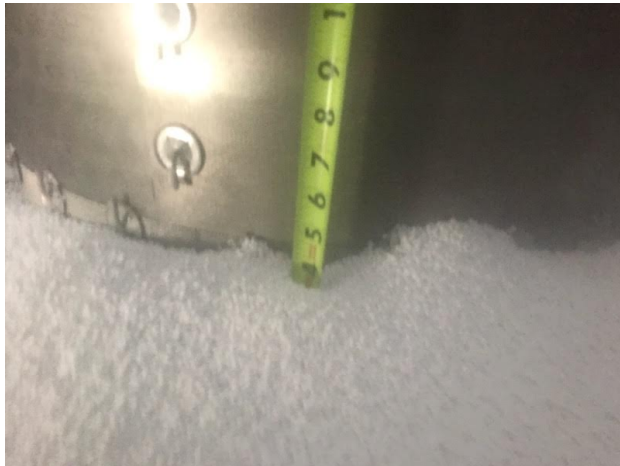
- Last week the VSA was ran at different flowrates to observe the performance. The flowrate was varied between 54000scfh to 85000scfh. The product purity varied from about 71.5% at lower rate to about 69% at higher flowrate. I also observed the purity at the initial cycles after the start up. During the initial cycles the purity was increasing about steadily and settled around ~71% initially.
- Due to bad/rainy weather for last few weeks at Dublin, the vessels emptying work was delayed till current week.
- Rolan plant services is onsite now and emptied one Adsorber vessel (R03) so far. The height of Alumina they found at the center column was about 3 to 4" high. See photos below.

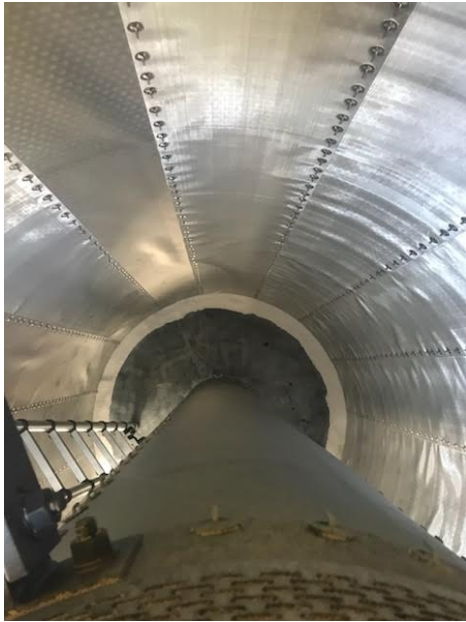
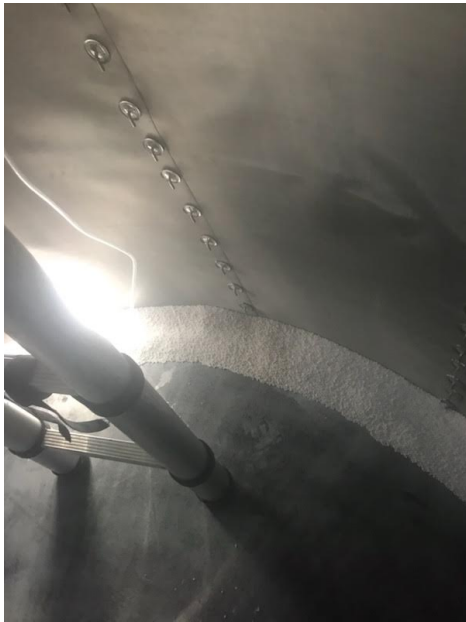
- Additional Alumina was removed from the vessel. Below is the photo of the vessel after removing excess Alumina from the bed.

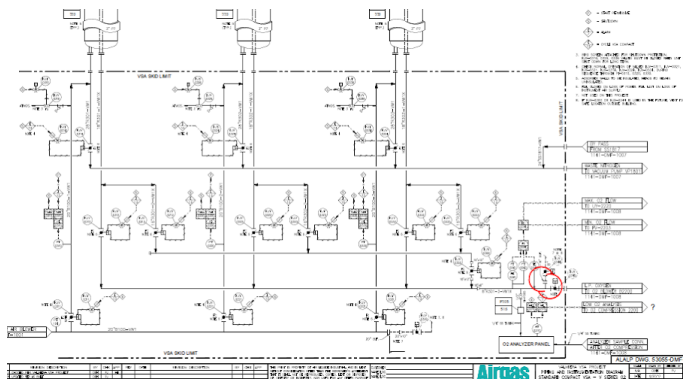
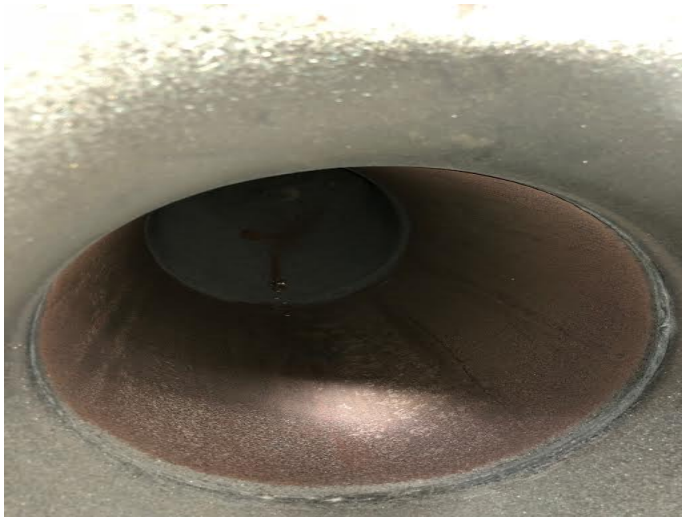
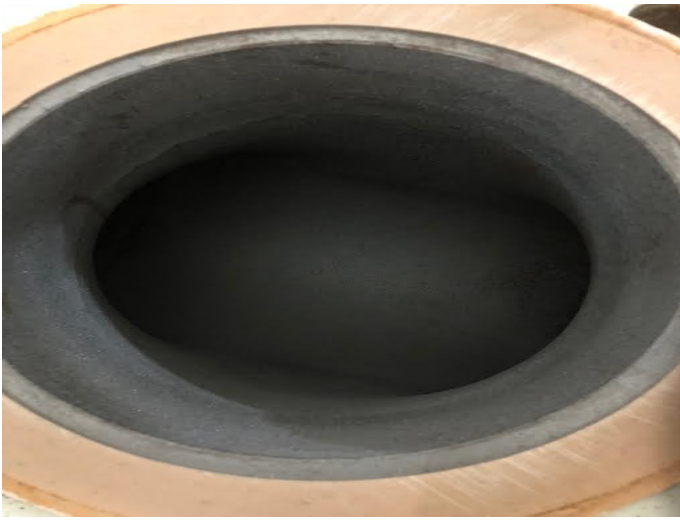
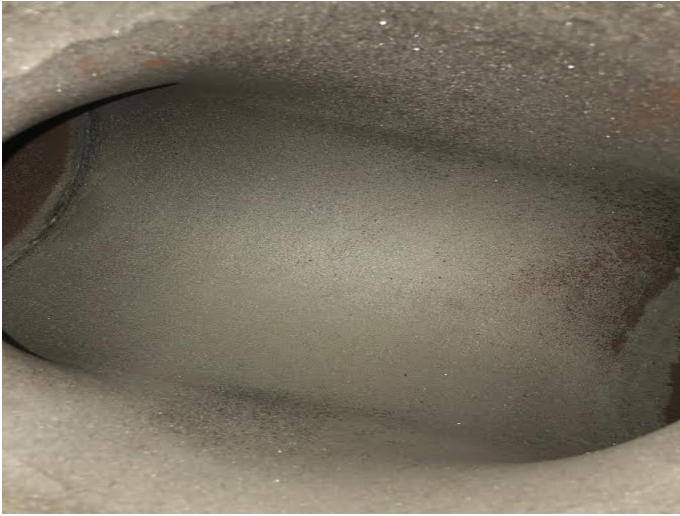
- Check the O2 header from the VSA skid for any Sieves, dust.
 - O2 header checked by opening 8" blind flange. No Sieves or dusting was seen in the pipe. See attached photos for the pipe internals. See clouded portion where the O2 header was opened.
 -
